6 PROCEEDINGS OF THE 1980 TRI-SERVICE
CONFERENCE ON CORROSION

5-7 NOVEMBER 1980
US AIR FORCE ACADEMY, COLORADO, Volume I.

CORROSION OF NAVAL SEA SYSTEMS
AN OVERVIEW

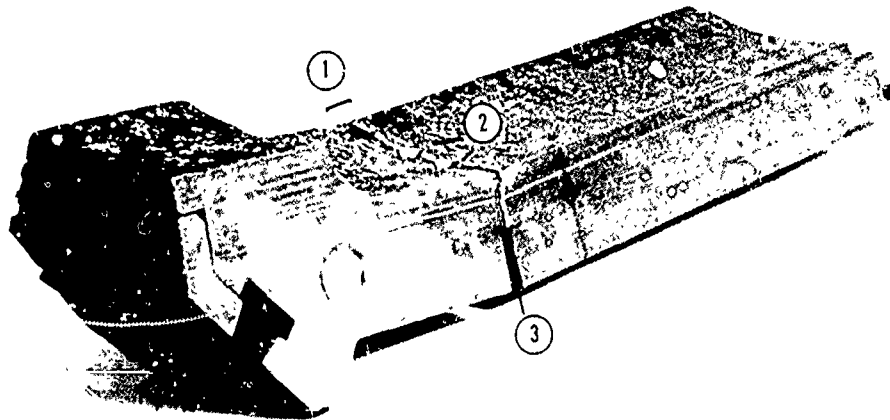
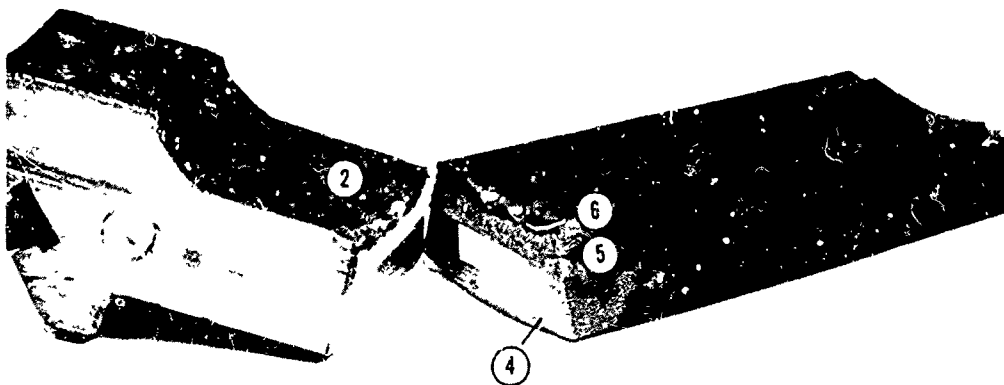
EDDY CURRENT AND SUBSURFACE SILVER NITRATE ON TEST SECTION

FRACTURE OF TEST SECTION TO REVEAL DEALLOYING ON FRACTURE SURFACE

1. Area inspected by eddy current
2. Excavations for subsurface silver nitrate test
3. Saw cut to define plane of fracture
4. Saw cut area
5. Fracture area
6. Dealloying revealed on fracture face

Figure 2- Inspection Procedure Evaluation Method

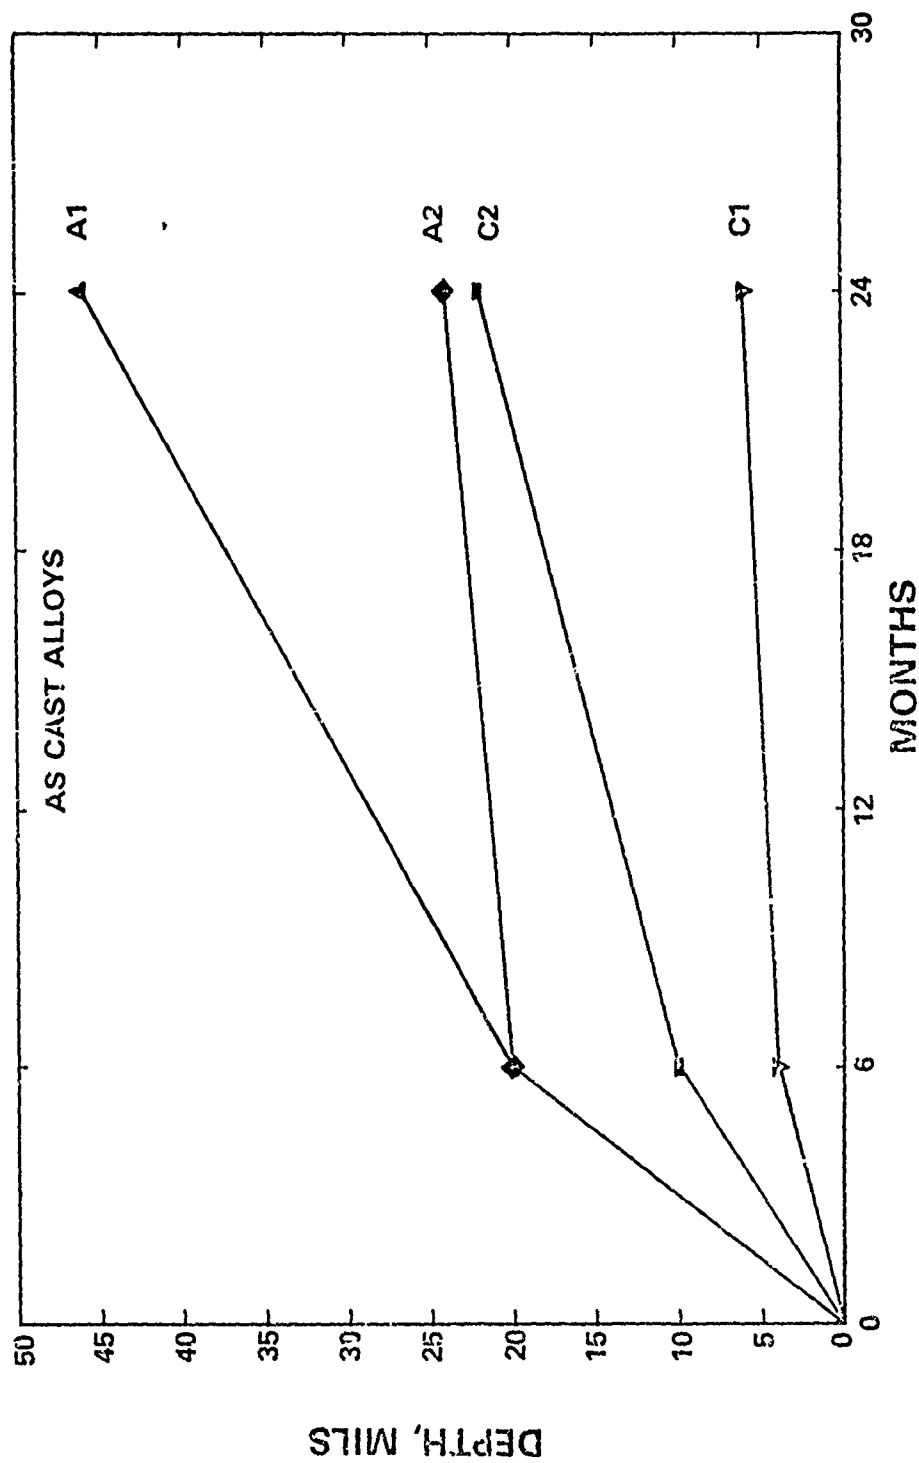
Figure 3 - Dealloying Depths Measured on As-Cast NAB Alloys After Six-Months and Twenty-Four-Months Immersion in Seawater

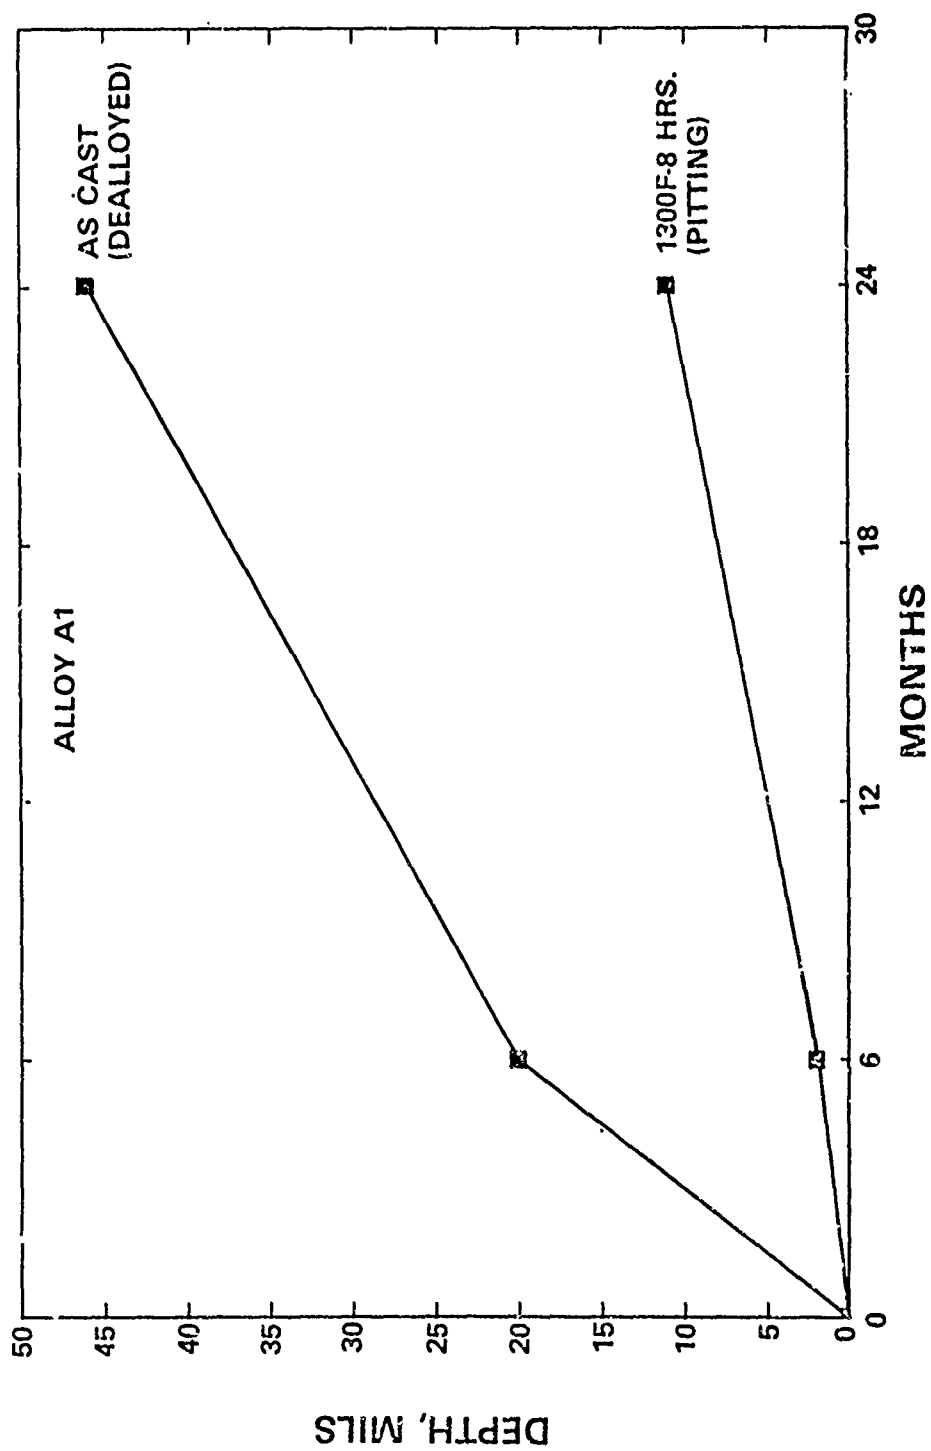
Figure 4 - Effect of Heat Treatment on the Seawater Corrosion Behavior of Alloy A1

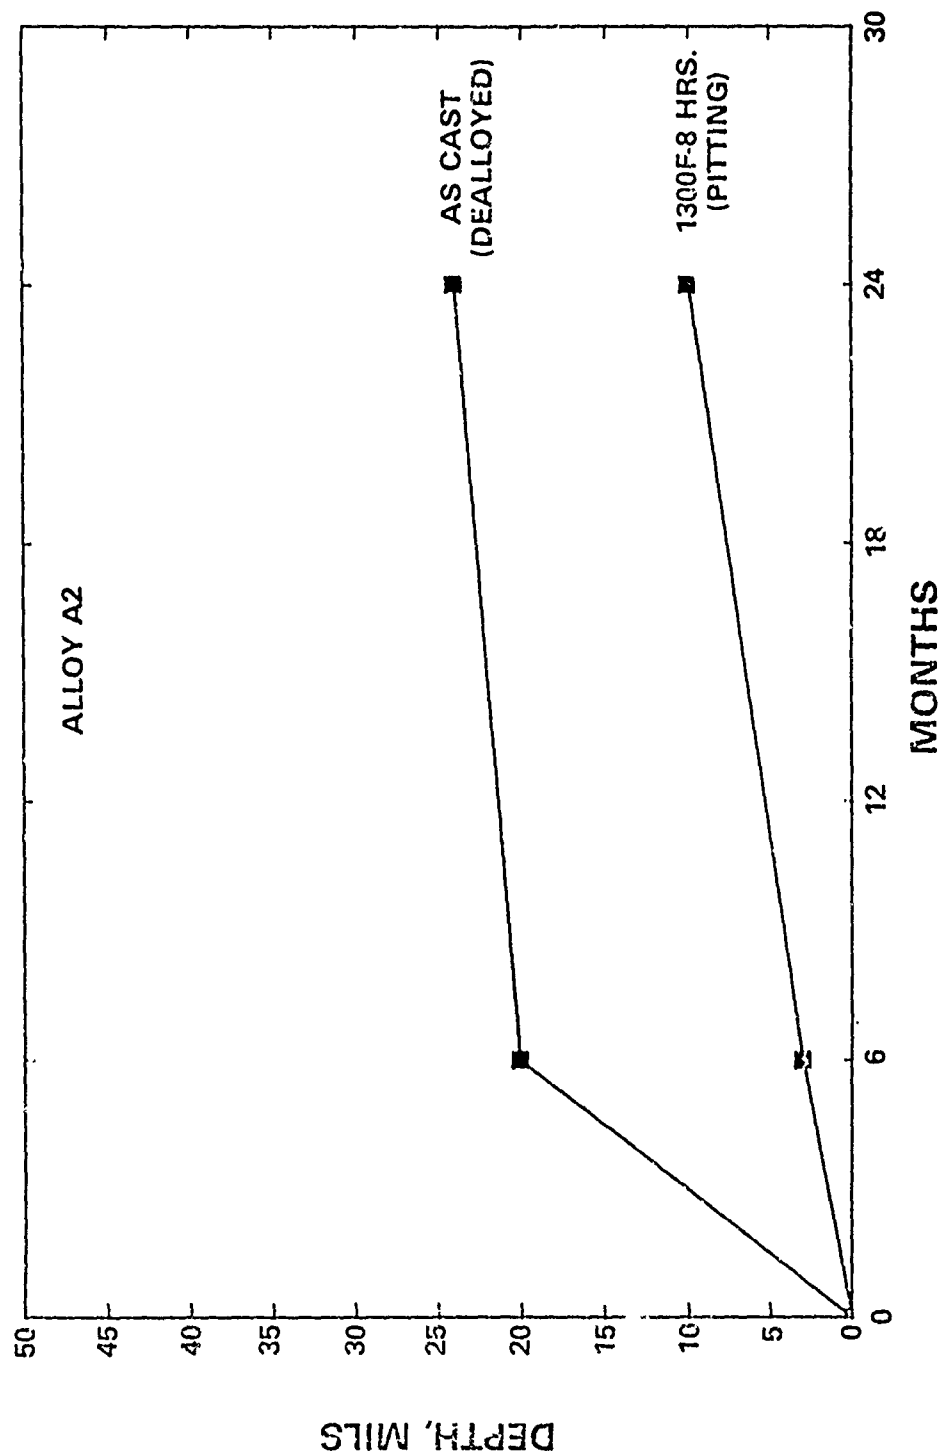
Figure 5 - Effect of Heat Treatment on the Seawater Corrosion Behavior of Alloy A2

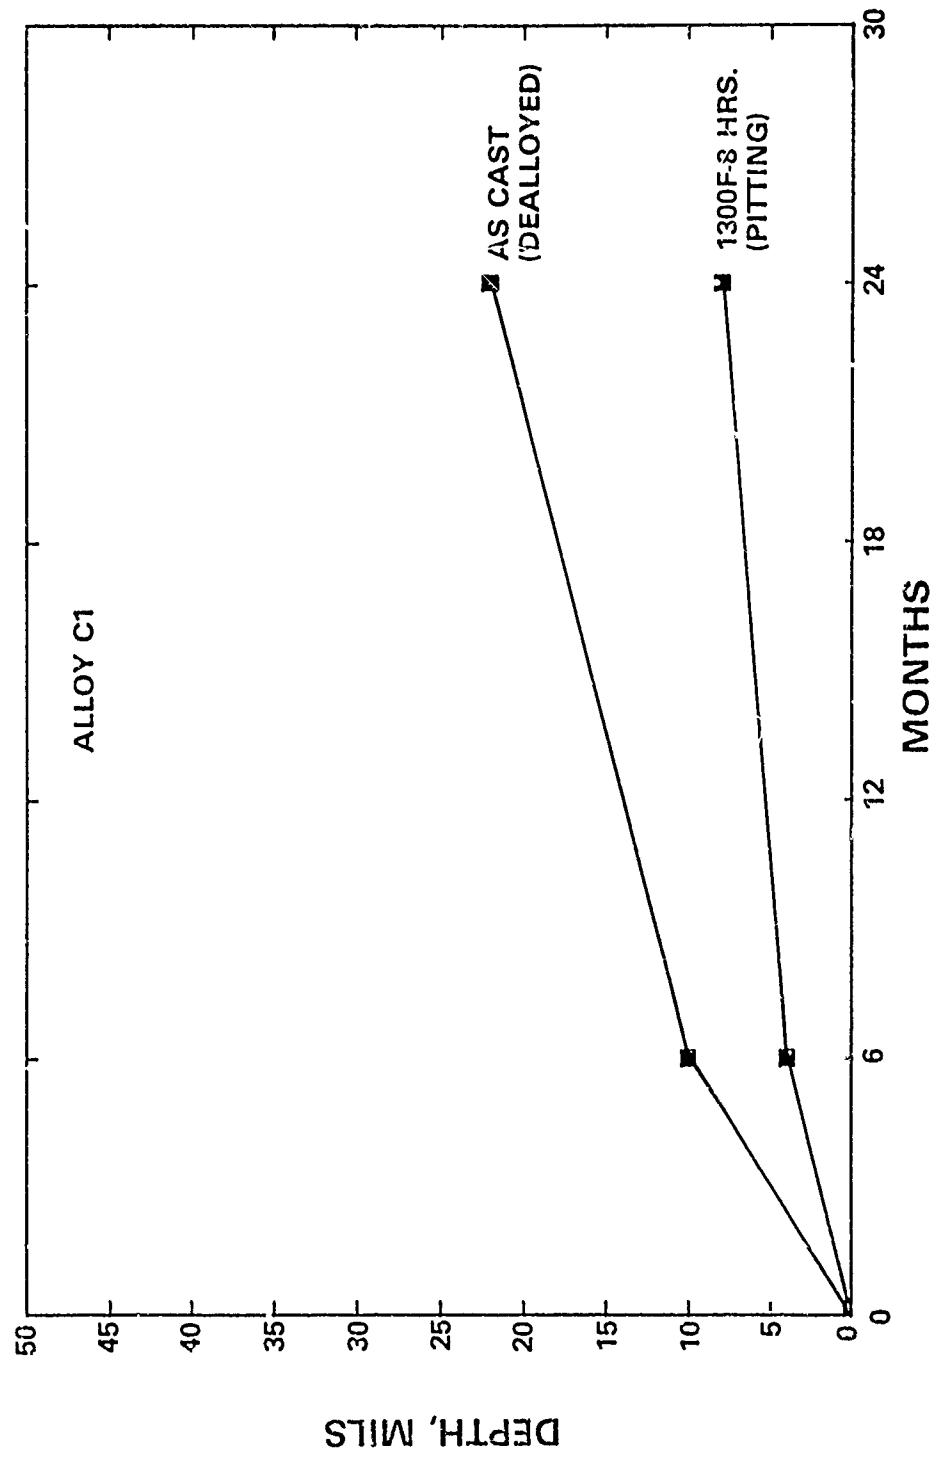
Figure 6 - Effect of Heat Treatment on the Seawater Corrosion Behavior of Alloy C1

- Figure - 6 Effect of Heat Treatment on the Seawater Corrosion Behavior of Alloy C1
- Figure - 7 Effect of Heat Treatment on the Seawater Corrosion Behavior of Alloy C2

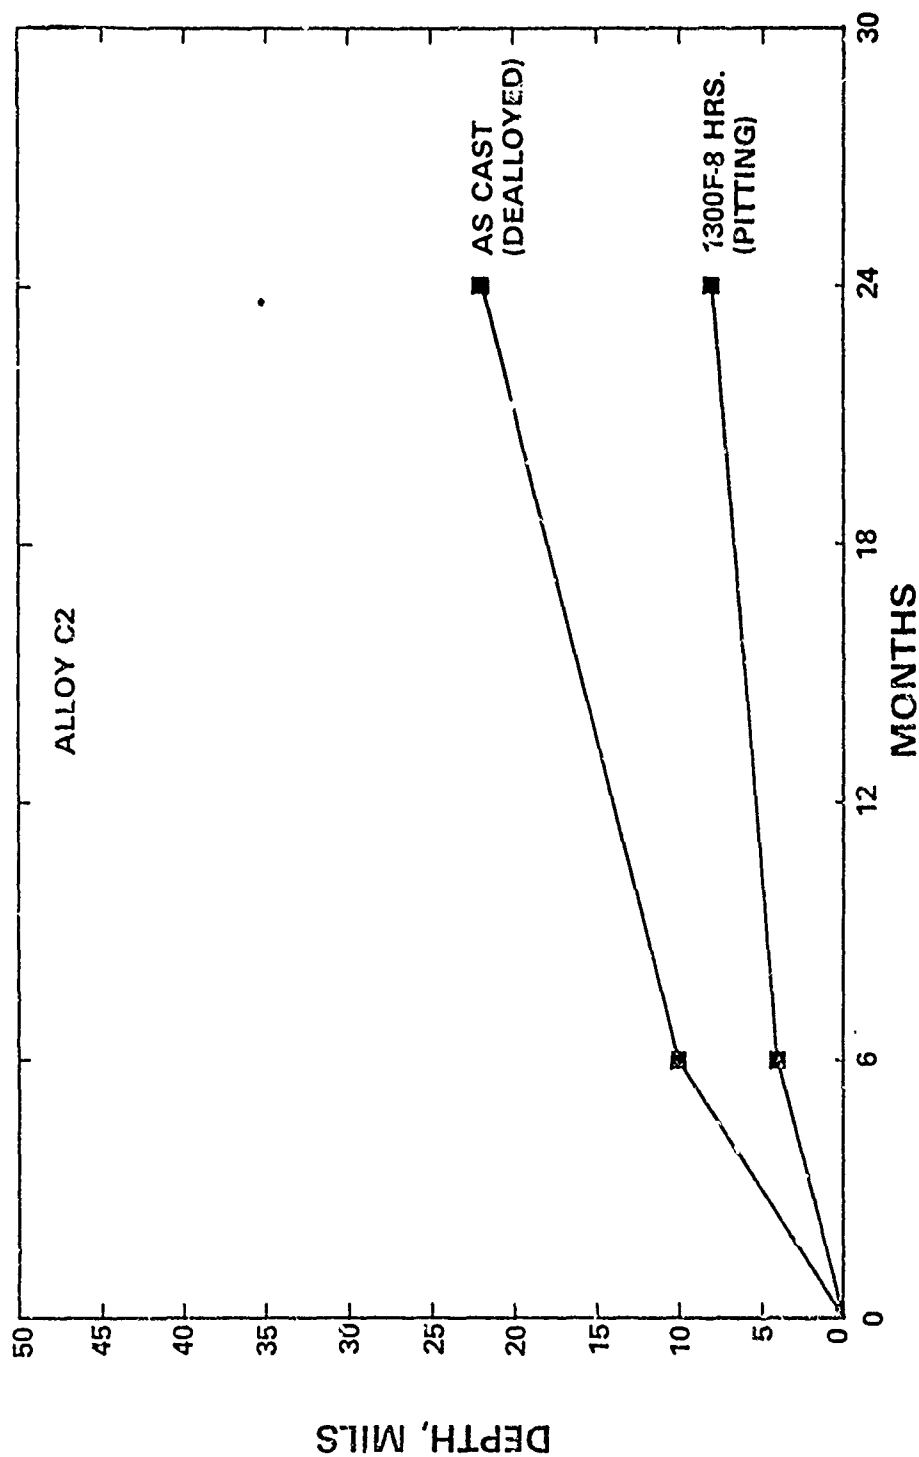
Figure 7 - Effect of Heat Treatment on the Seawater Corrosion Behavior of Alloy C2

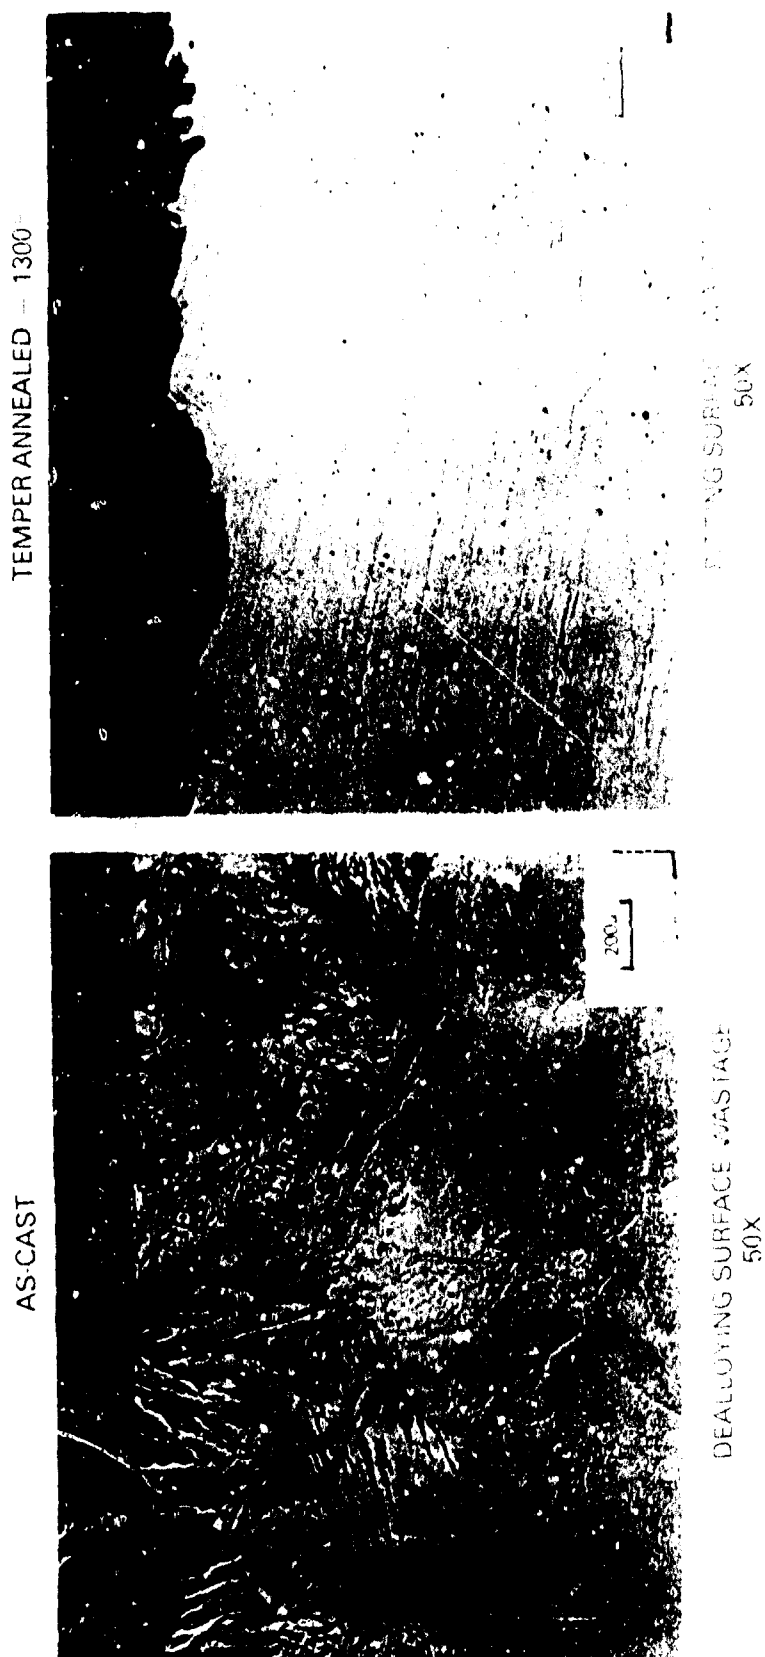
Figure 8- Corrosion of As-Cast and Temper Annealed Nickel-Aluminum Bronze Alloys After 24-Months Immersion in Seawater, Alloy Al

- Figure - 8 Corrosion of As-Cast and Temper Annealed Nickel-Aluminum Bronze Alloys After 24-Months Immersion in Seawater, Alloy A1
- Figure - 9 Corrosion of As-Cast and Temper Annealed Nickel-Aluminum Bronze Alloys After 24-Months Immersion in Seawater, Alloy A2

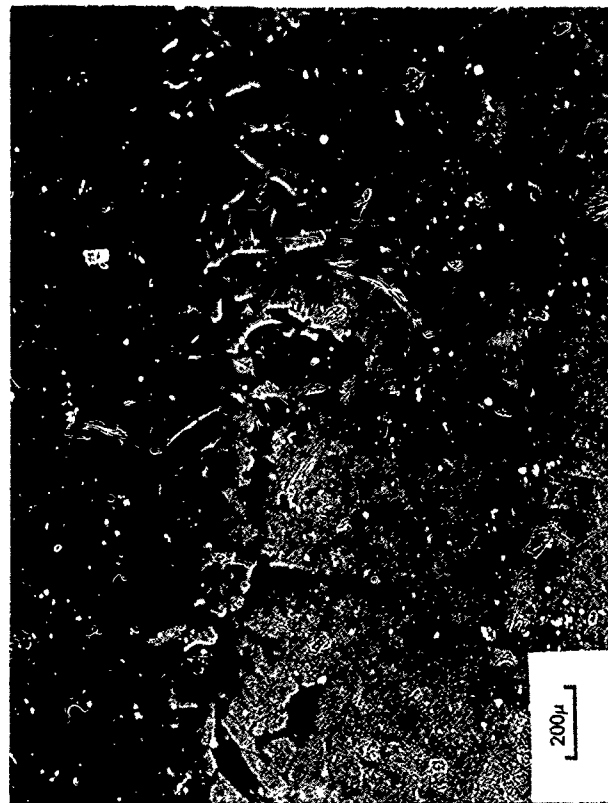
AS-CAST

DEALLOYING/SURFACE WASTAGE
50X

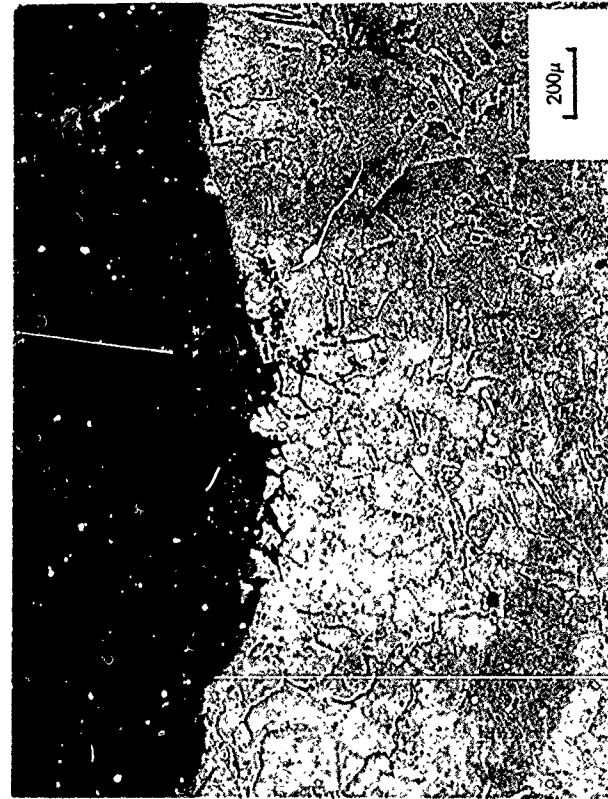
Figure 9- Corrosion of As-Cast and Temper Annealed Nickel-Aluminum Bronze Alloys After 24-Months Immersion in Seawater, Alloy A2

TEMPER ANNEALED — 1300°

PITTING/SURFACE WASTAGE
50X

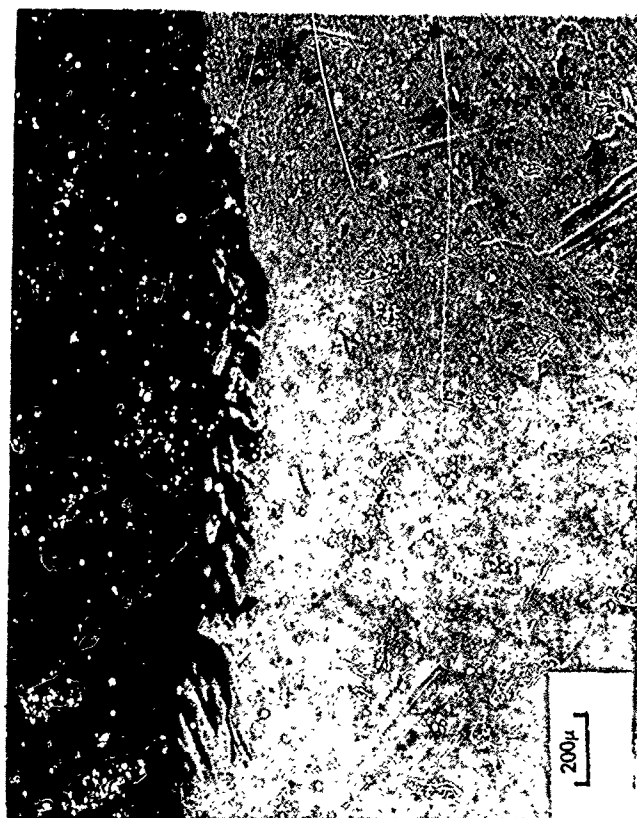
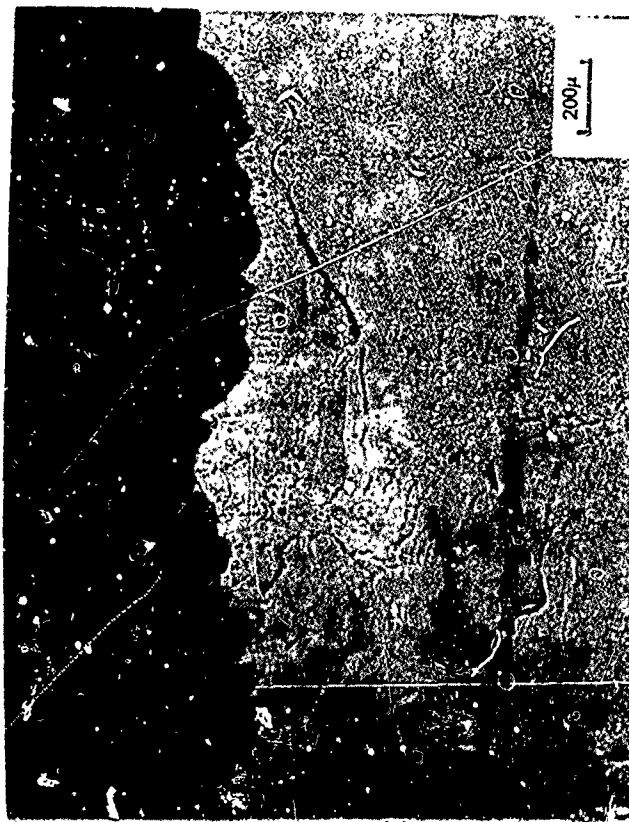
Figure 11- Corrosion of As-cast and Temper Annealed Nickel-Aluminum Bronze Alloys After 24-months Immersion in Seawater, Alloy C2

AS-CAST

DEALLOYING/SURFACE WASTAGE
50X

TEMPER ANNEALED — 130G°

PITTING/SURFACE WASTAGE
50X

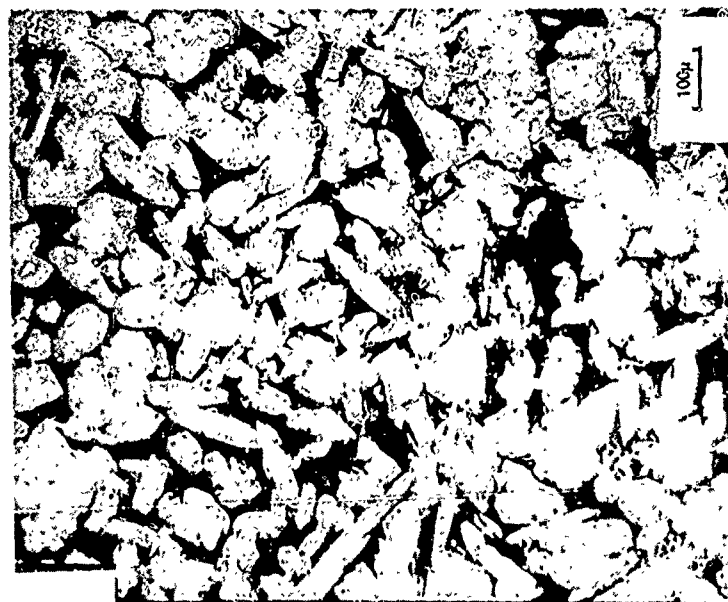
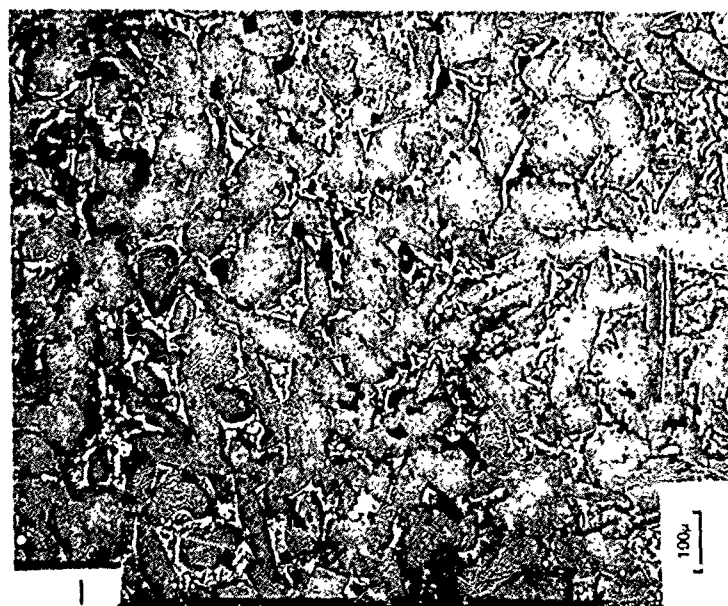
Figure 13- Aluminum-Bronze Casting: Microstructural Comparisons
of Dealloyed Metal and Sound Metal

SOUND METAL
100X

DEALLOYD METAL
100X

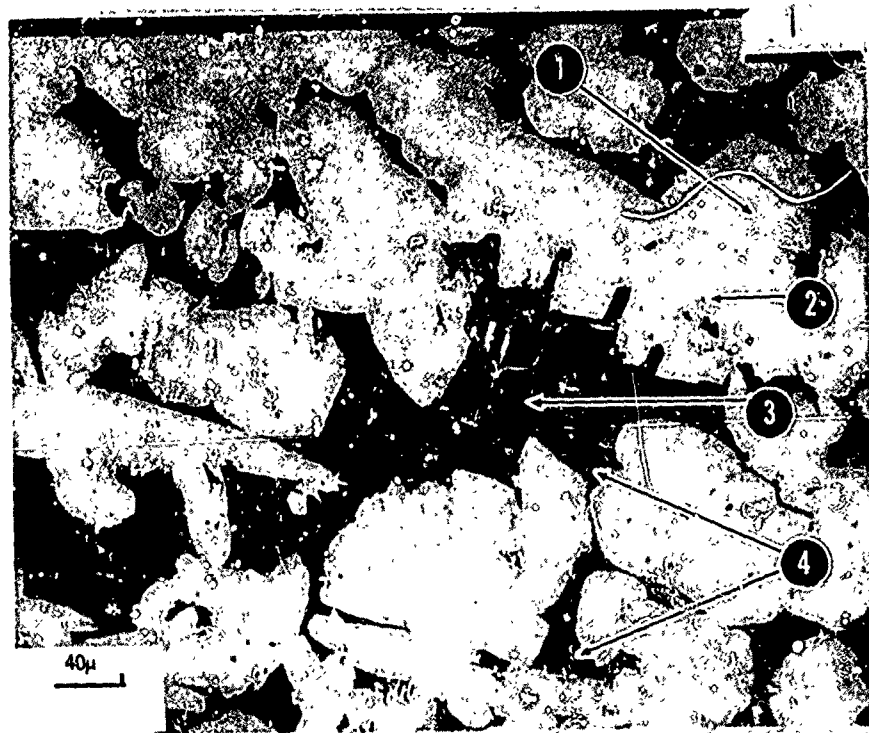
Figure 14- Microstructural Features of Aluminum-Bronze
(MIL-B-16033, Class 3 Alloy) (250X)

- 1 ALPHA PHASE
- 2 IRON-KAPPA PHASE
- 3 RETAINED BETA
- 4 ALPHA + GAMMA-2 EUTECTOID

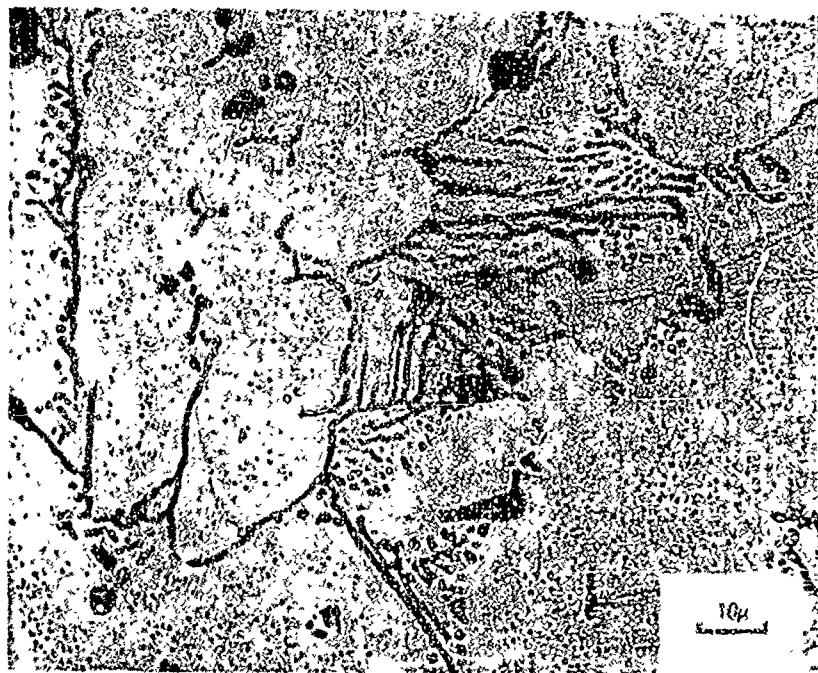
Figure 15- Corrosion Attack of Ni-Kappa and Fe-Kapp Phases
on NAB Casting Used for Seawater Service

1000X

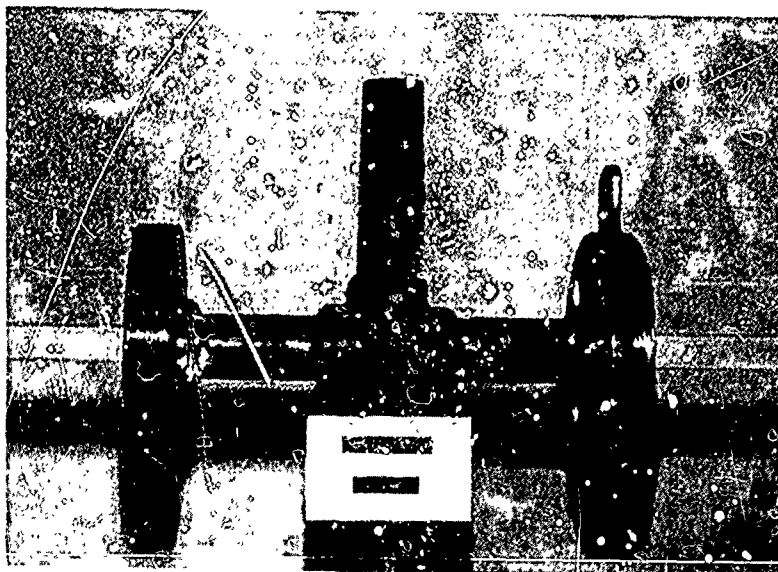
FIGURE 1 - UNCOATED FLANGE-SHAPED SPECIMEN;
15 in. LONG WITH 7 in. DIAMETER FLANGE

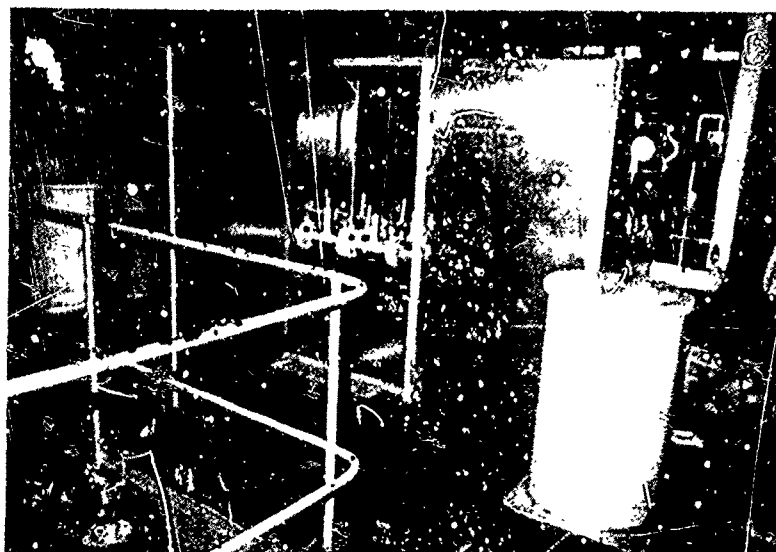
FIGURE 2 - ASSEMBLED SPRAY CABINET

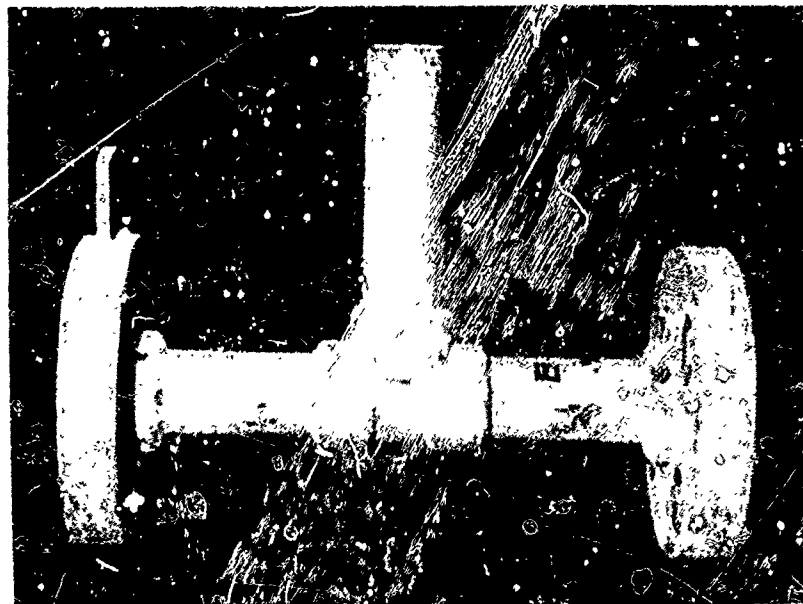
FIGURE 7 - T-BAR-SHAPED SPECIMENS COATED WITH
VSA (OXI-ACETYLENE) PLUS SA SLATE

Photographic and descriptions of the surface conditions of each of the valve-shaped specimens were prepared. Typical photographs of the valve-shaped specimens after the complete exposure cycles are shown in Figures 7 through 11. Comparisons of the various types of coatings made based on the general appearances are presented below.

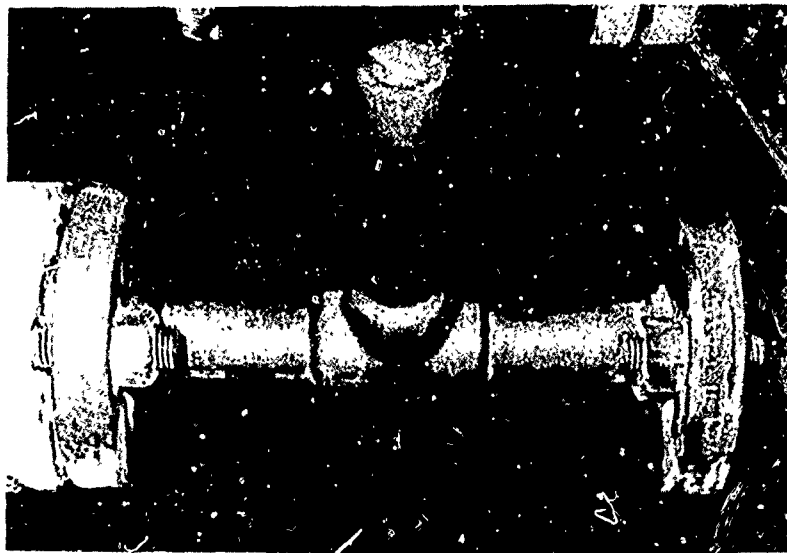
FIGURE 8 - FLANGED-SHAPED SPECIMEN COATED WITH
SERMETAL 725

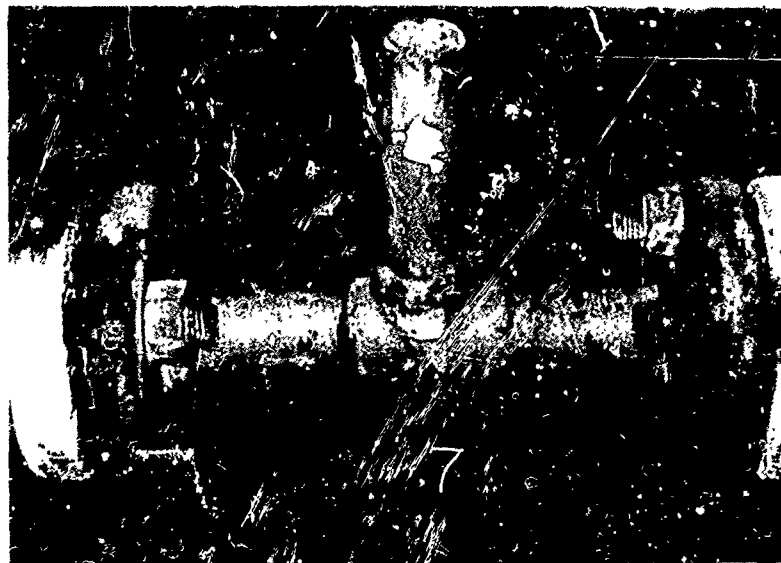
FIGURE 9 - FLANGED-SHAPED SPECIMEN COATED WITH
SERMETAL 229 PLUS 737 STALER

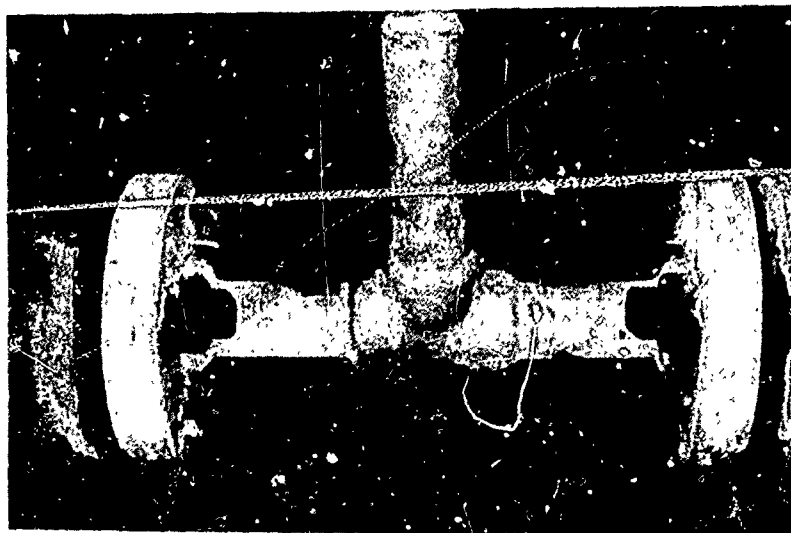
FIGURE 10 - FLANGED-SHAPED SPECIMEN COATED WITH
WSA (OXY-ACETYLENE) PLUS DOD-P24555 PAINT

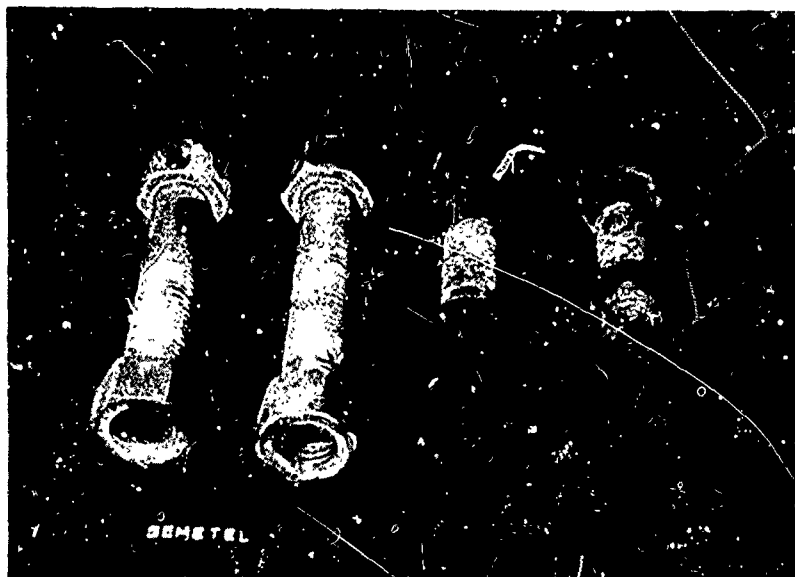
FIGURE 12 - COMPARISON OF SERMETAL 725 COATED
HARDWARE WITH STUD ASSEMBLIES
PREVIOUSLY COATED WITH DOD-P24555
PAINT AND SA SEALER

Only the stud/nuts coated with "Sermetei 725 fastener formulation" showed good corrosion resistance during the test. The stud/nuts coated with the SA sealer and the DOD-P-24555 showed rusting after 17 days; the IVD studs/nuts showed significant corrosion at the 52 day inspection. The Sermeteled stud/nuts were only slightly rusted at the completion of the test (146 days). Photograph showing comparison of hardware is shown in Figure 12. The Sermeteled coating on the nuts beneficially slowed down the "sacrificing" action of the aluminum spray on the flanges. In many of the specimens, the flange surface around the nuts coated with the other methods were corroded; however, the areas around the Sermeteled nut was still protected.

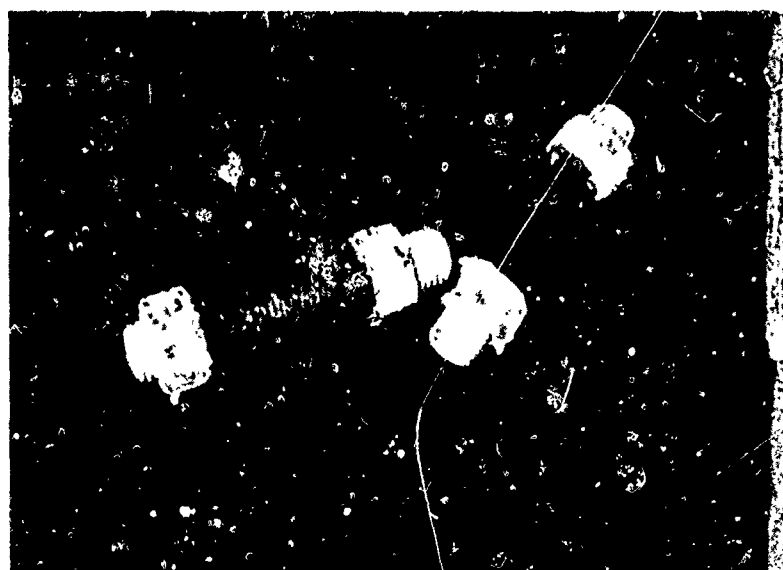
FIGURE 13 - STUD/NUT ASSEMBLIES USED IN
NUT REMOVAL TEST

Photographs of the 1"-8 stud/nut assembly for the nut removal (backing-off test) are shown in Figure 13. Severe corrosion had occurred in the uncoated central portion of the stud; however, the WSA end threads showed no rusting. Upon backing-off of several of the studs, the coating flaked off and offered little resistance to the travel of the nut; however, other nuts (approx 2/3) became bound and could not be removed. The problem of binding increased as the number of exposed threads increased. Also the studs from which the nuts could be removed would have to be cleaned-up of remnant aluminum if the studs were to be reused.

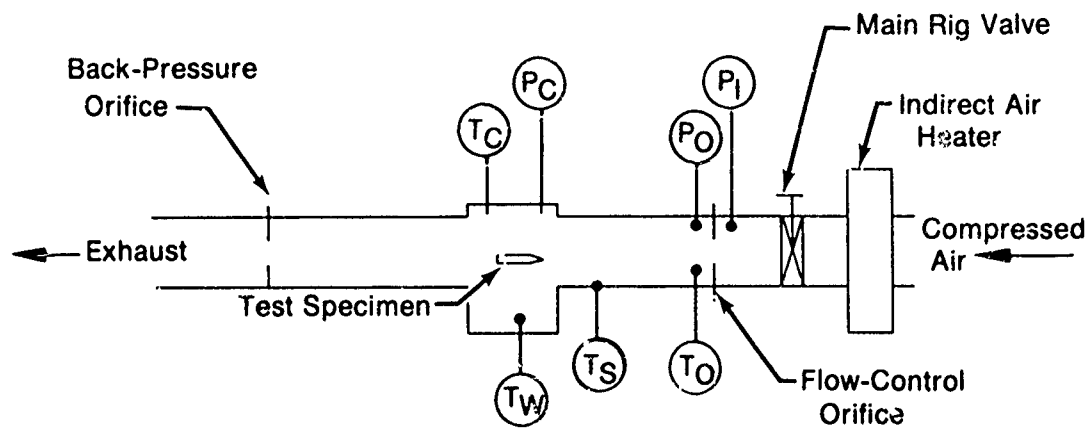
FD 139565

P_I = Orifice Upstream Pressure
 P_O = Orifice Downstream Pressure
 P_C = Test Chamber Pressure
 T_O = Orifice Air Temperature
 T_S = Rig Skin Temperature
 T_C = Test Chamber Temperature
 T_W = Window Temperature

Air, supplied from a large compressor, passes through a gas-fired indirect heater and a flow-measuring orifice prior to entering the test section. The test section, shown schematically in figure 1, consists of a 2 by 5 cm (0.75 by 2.0 in.) rectangular channel with a bellmouth and 7.5 cm (3.0 in.) of straight section upstream of the test specimen leading edge. The test specimen mounts in a carrier which is inserted into the test section. Orifice plates, upstream and downstream of the test section, provide control of flowrate and pressure level. Thermocouples provide temperatures at the flow-measuring orifice, in the specimen test chamber, on the rig skin, and on the laser and camera windows. Airstream flow is determined by calculation using the pressure differential (ΔP) across the orifice.

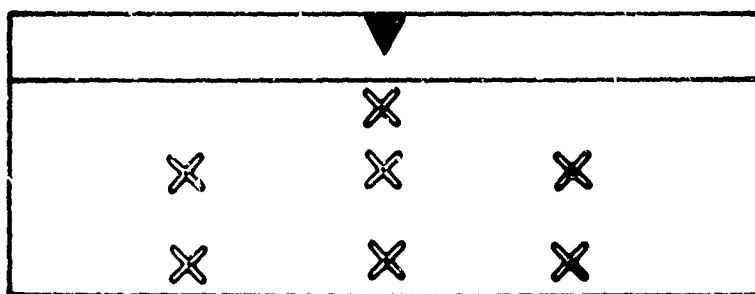
X = Thickness Measurement Point

Test specimens were prepared for combustion tests in the configuration shown in figure 4. The dimensions of each machined specimen were measured and recorded; specimens which did not meet the specifications noted in figure 4 were rejected. An average of micrometer readings taken at the seven points shown in figure 5 determined specimen thickness.

Test specimens were prepared for cascade combustion tests in the configuration shown in figure 8. The dimensions of each sheared specimen were measured and recorded; specimens which did not meet the specifications noted in figure 8 were rejected. Specimen thickness was recorded as the average of micrometer measurements taken at the seven points shown in figure 5.

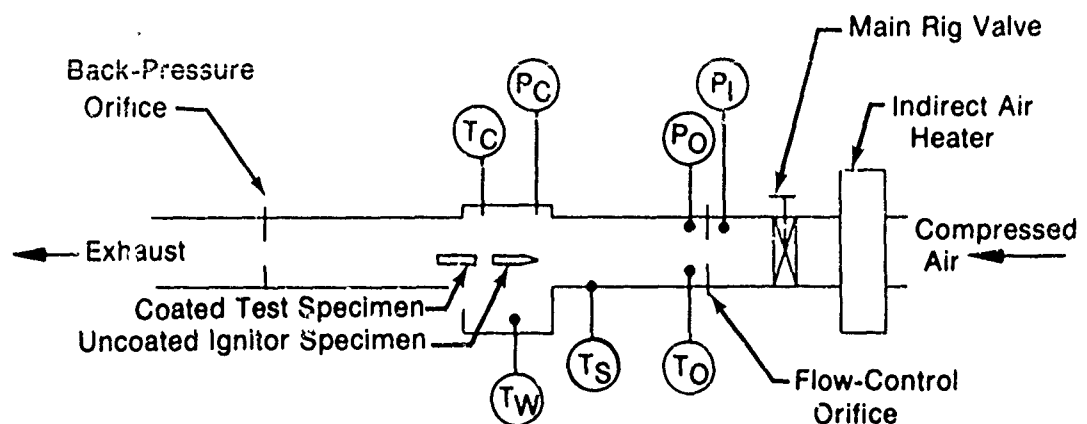
Figure 6 Titanium Combustion Rig — Cascade Ignition

- P_1 = Orifice Upstream Pressure
 P_0 = Orifice Downstream Pressure
 P_C = Test Chamber Pressure
 T_0 = Orifice Air Temperature
 T_S = Rig Skin Temperature
 T_C = Test Chamber Temperature
 T_W = Window Temperature

In later combustion tests, modification of the combustion rig permitted molten metal ignition (cascade), as shown in figure 6. Enlargement of the specimen holder to a capacity where two specimens could be held is shown in figure 7. The upstream specimen, composed of anodized Ti 8Al-1Mo-1V, ignites by use of the laser (as described earlier), thereby subjecting the downstream specimen to molten metal impingement.
